# **CASE HISTORY**

## Clamp and Power line Protection at Wind Power Transfer Station

(風力発電所でのクランプと電力線の保護)

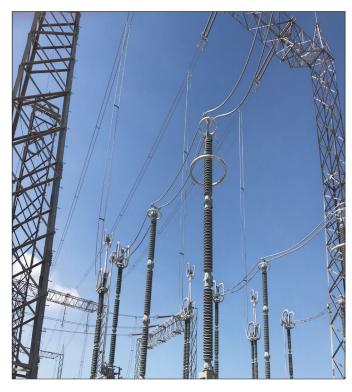
風力発電所の送電線に取り付けられているクランプは、設置後、間もなく激しく腐食しました。 これは、設置されている場所が海の近くにある強風と砂が巻き起こる厳しい環境によるものでした。

防錆処理の作業開始前に中継基地の電源を切りました。次にクランプを取り外し、機械的な研磨により腐食の大部分を除去しました。次に、洗浄防錆剤の VpCI-415 を使用して部分洗浄し、乾燥後、エレクトリコア VpCI-239 (屋外用接点防錆剤)を塗装コーティング剤が塗れないクランプの内側に塗布しました。次に、VpCI-396 をプライマーコートとして塗布し、2~3 時間乾燥させ、VpCI-384 をトップコートとして塗布しました。 らに、クランプの両側のワイヤーのセクションは、汚染物質のさらなる侵入からワイヤーを保護するために VpCI-396 でコーティングしました。下部には、VpCI-368WAX 状硬化油性防錆剤が変電所周辺の可動部品に使用されました。最後に構造物として、MCI-2020 をコンクリートと支持構造との間と周辺に塗布されました。そして、風力発電所の補修部分のコンクリートのモルタルにMCI-2005 を混ぜこみ、内部の鉄筋を保護しました。
